Manhole Inspection Summary

Manhole # S69M__031MH

Insp Date: **1/29/08 12:37 PM**

Location Address: **1102 Bethlehem Ave.**

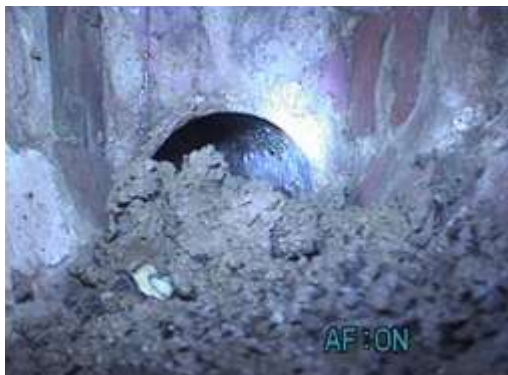
Defect 2

Condition: ☐ Sound ☐ Cracked ☐ Root Intrusion ☐ Deteriorated ☐ Leaks ☒ **Debris**

deposit settled encrustation in trough in front of the incoming 4 o'clock connection

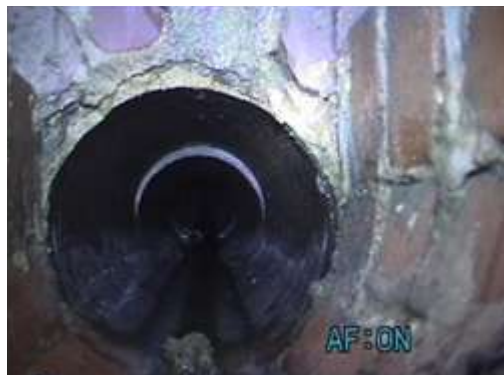
Defect 1

cracked pipe seal 10 to the 1 on the outgoing 12 o'clock pipe

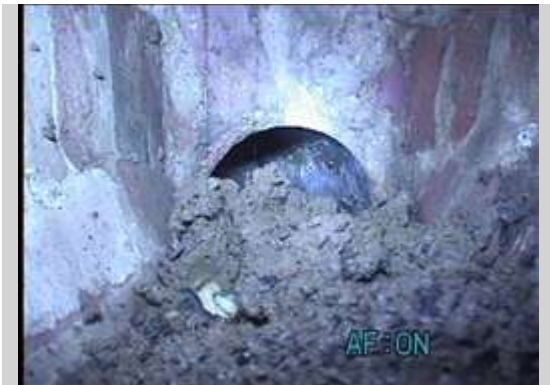
4 O'Clock Inflow

deposits settled hard encrustation in front of pipe

Deposits: ☐ None ☐ Mud ☒ ~~Sludge~~ ☒ Debris ☐ Grease

Silt Depth: **3** (in.) Deposits Extent: **Heavy**

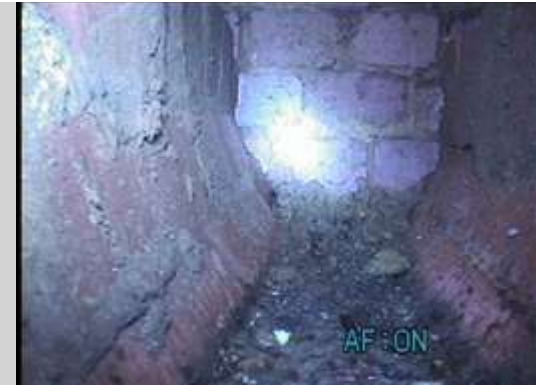
6 O'Clock Inflow

capped off and blocked by brick

Connects To: **Stub connection / abandoned**
